Fish Passage Evaluation Field Log

Stream: Blue Cr Upper culvert

Road # 054 Passage ID: _____

Date: July 7, 2016 Crew: Neal

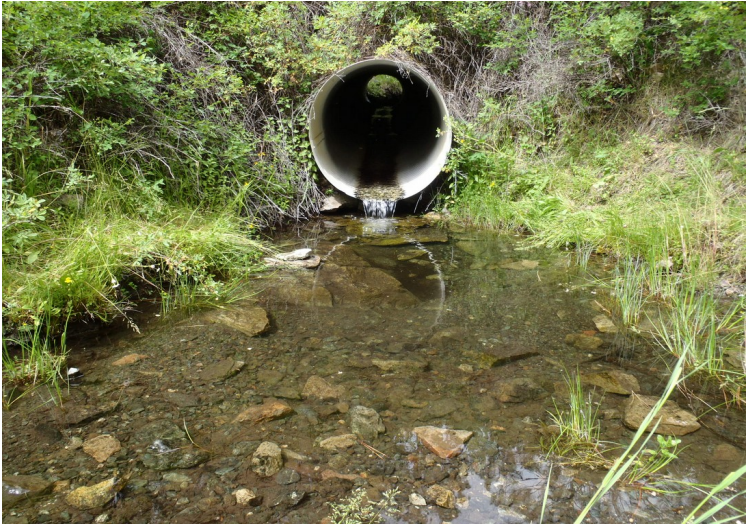
Drop to Pool: 0.25 ft [perch height]

Depth of Pool: 1.5 ft

8 large O.Mykiss seen in outlet pool

Blue Cr upper culvert outlet

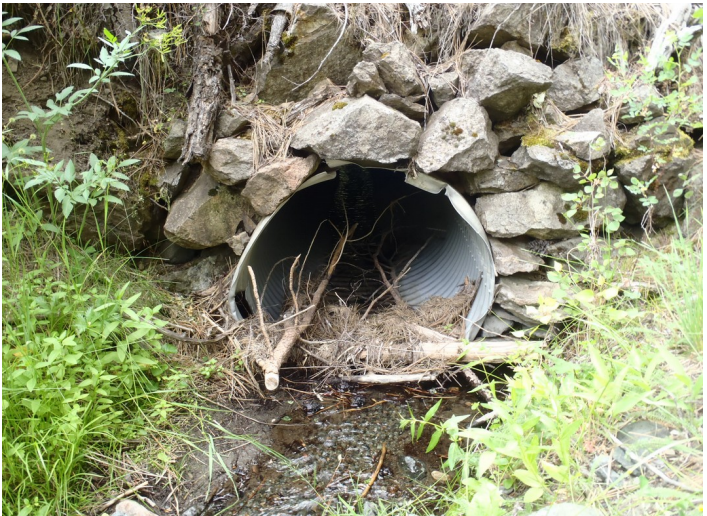
Other Culvert sides damaged at inlet

Substrate inside of Culvert: None except branches plugging inlet

Blue Cr upper culvert inlet

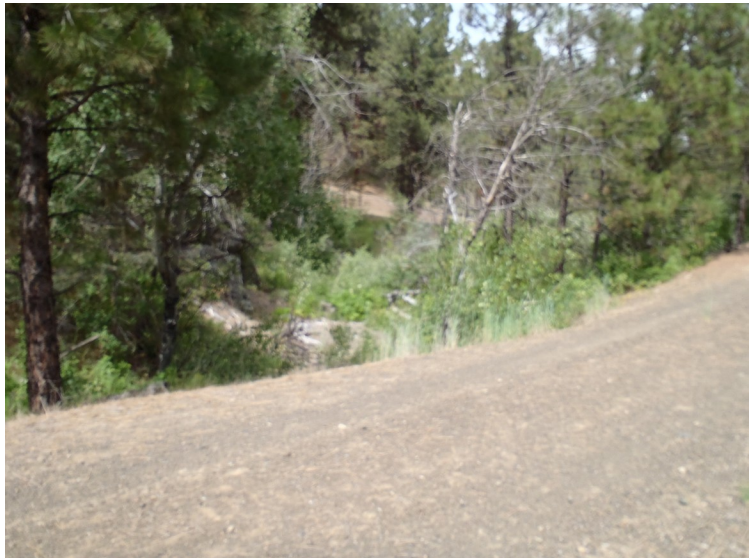
Looking upstream across road
