## Fish Passage Evaluation Field Log

Stream: Sfk Deer Cr check dams

Date: July 19, 2016 Crew: Neal

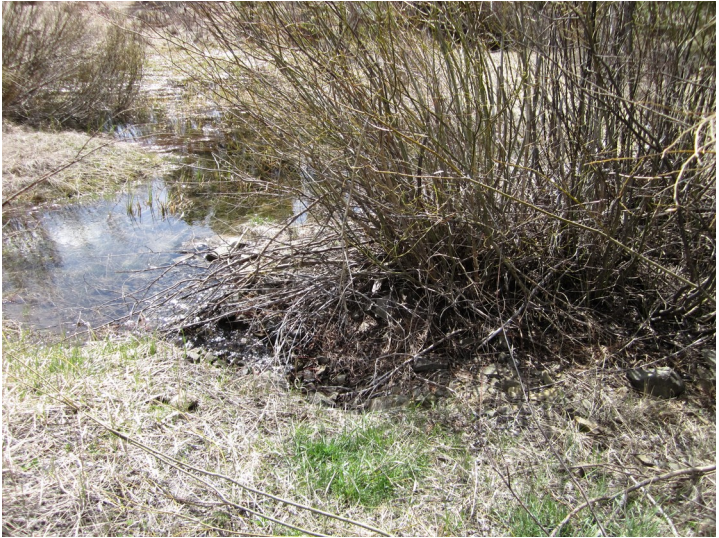
*Sfk Deer Cr disappearing in check dam #14*
