Fish Passage Evaluation Field Log

Stream: Nfk of Deer Cr rock check dams

Date: July 22, 2016 Crew: Neal

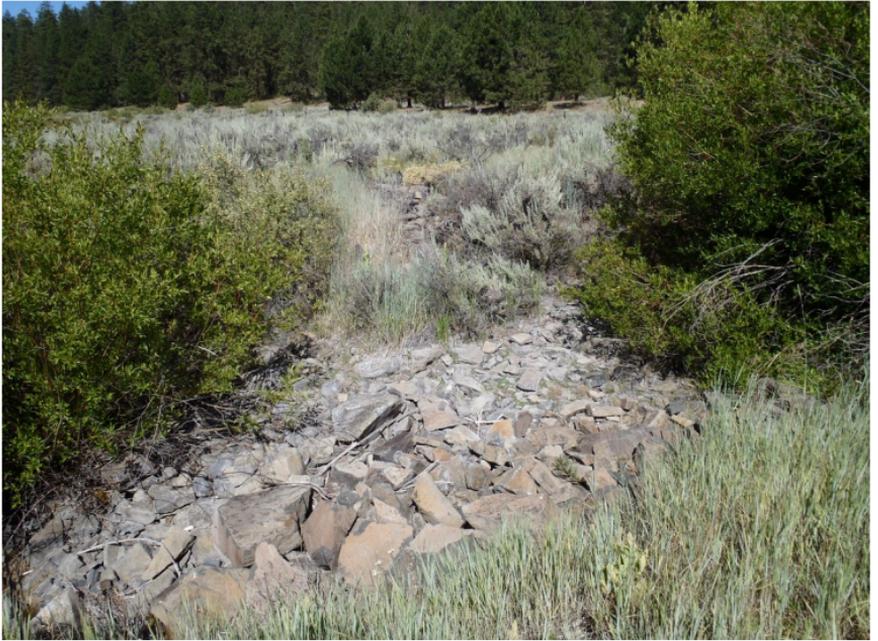
Nfk of Deer Cr check dam #6

dams are porous to water, stopped all sediment flow and remain barriers to fish movement during all but the highest flows. Corrections need to be made in the form of sealing the face and the spillway of each impassable dam. Or the alternative of digging a new stream channel around them and using the excavated material to cover the dams. They are located in, and block access to, some of the best summer rearing habitat in Deer Creek and Dead Injun Creek.

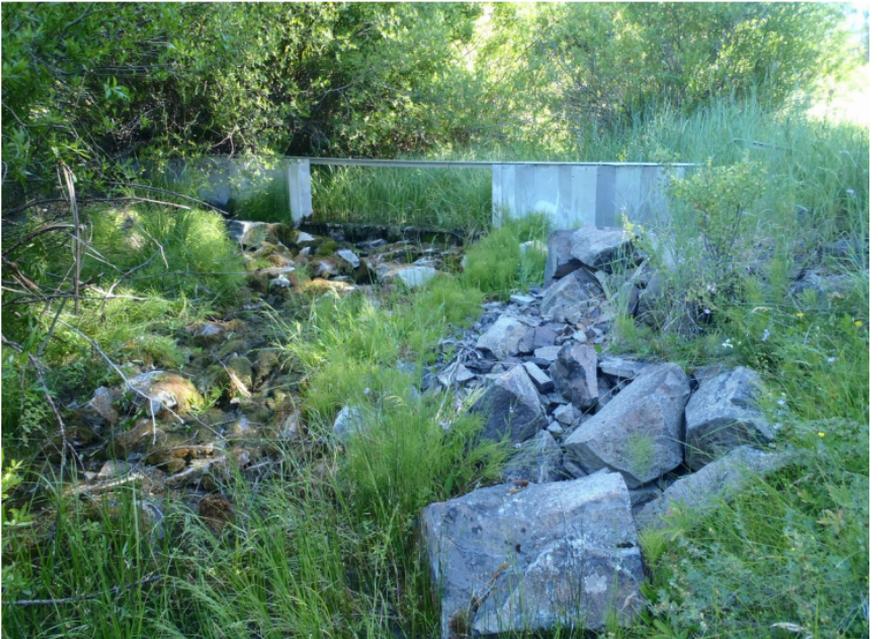
Nfk of Deer Cr check dam #7 with flow weir
