## Fish Passage Evaluation Field Log

Stream: Deer at Buck Cr Rd 304

Date: July 6, 2016 Crew: Neal

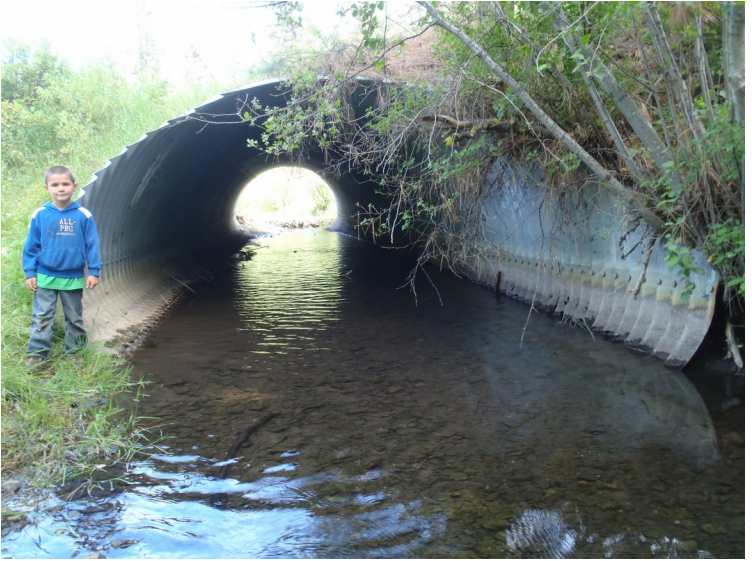
**Other** A few rust holes on side of outlet

*Deer Cr culvert at Buck Cr Road outlet- PASSABLE*

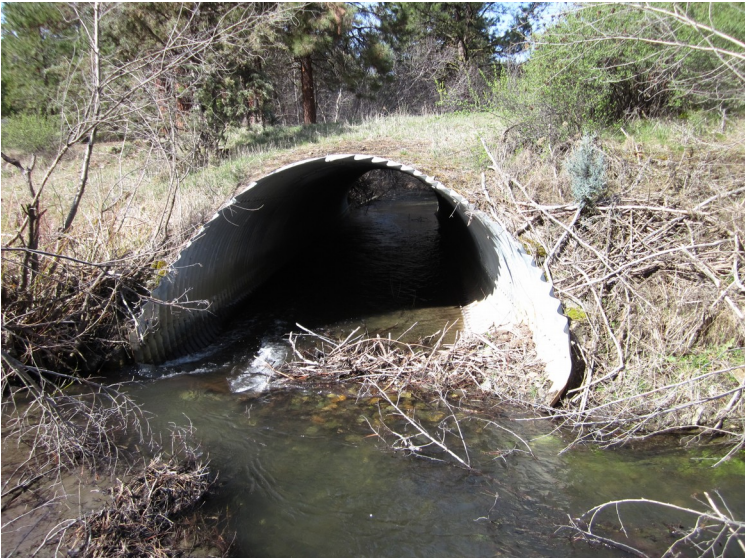
Condition: Bent inlet | **Debris plugging inlet** | Bottom worn through | Water under culvert |

Blockage: None | <10% | **>10%**

Beaver Created Obstruction: **Yes** | No

*Inlet can become blocked by debris and beaver dams*
