## Fish Passage Evaluation Data Sheet

Stream: Duncan Cr Fence Headcut

Date: 6/14/17 Crew: Neal

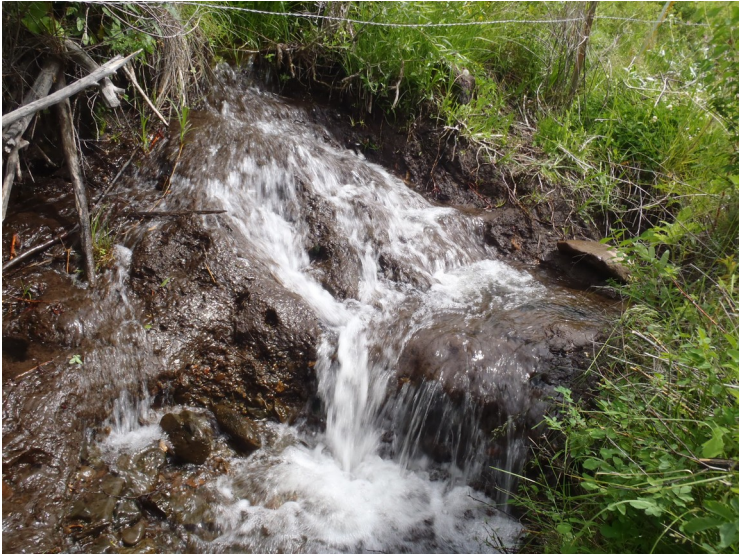
*Headcut occurs right below boundary fence*

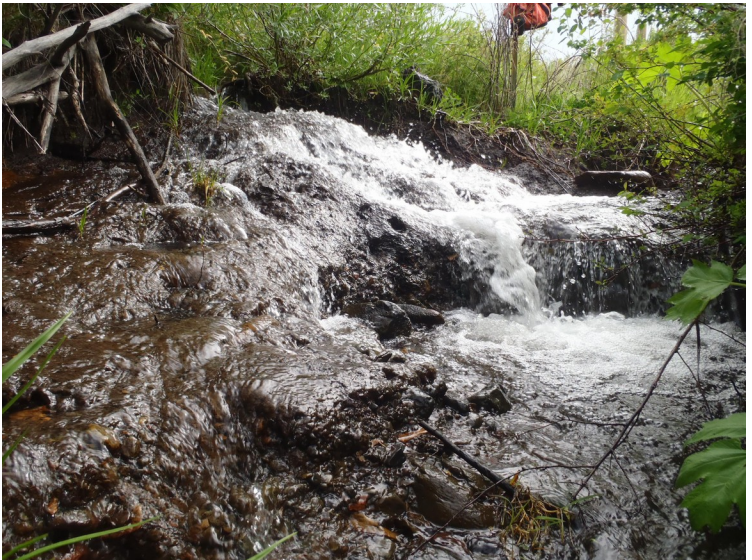
*View from stream bed level*
