Fish Passage Evaluation Data Sheet

Stream: Sugar Cr culvert @ 011 rd

Road # 011 Passage ID: _____

Date: 7/18/17 Crew: Neal

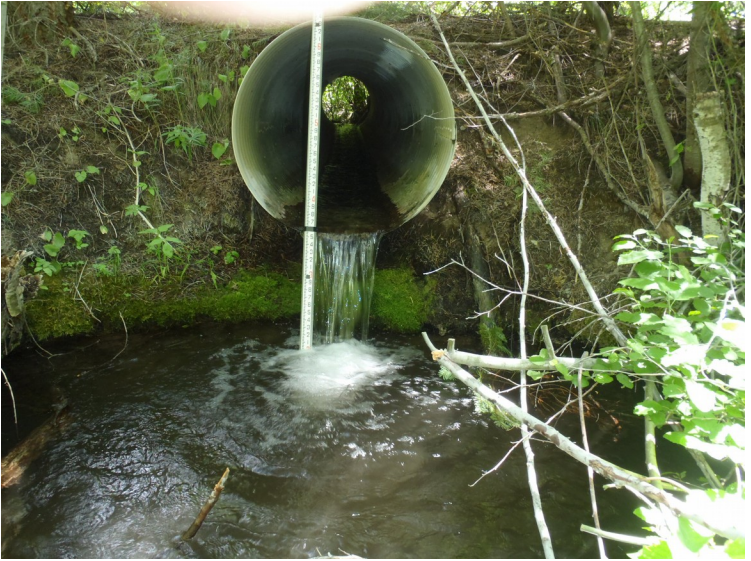
Other: Culvert roof is collapsing

Drop to Pool: 1.8 ft [perch height]

Depth of Pool: 2.3 ft Length of Jump Pool: 17.0 ft

Sugar Cr culvert outlet

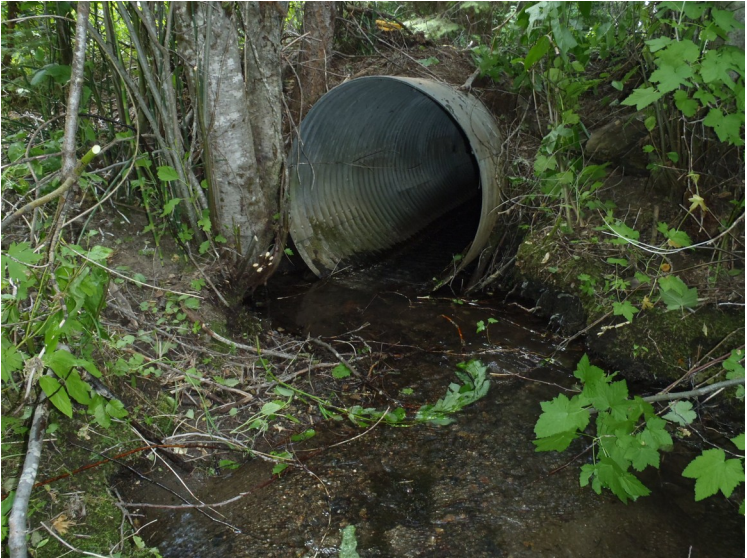
Condition: Bent inlet | **Debris plugging inlet** | Bottom worn through | Water under culvert |

Road Skewed from Culvert: 5 degrees

Intlet showing misalignment with stream
