Fish Passage Evaluation Data Sheet

Stream: Duncan 4ft Falls

Date: <u>11/19/17</u> Crew: <u>Neal</u>

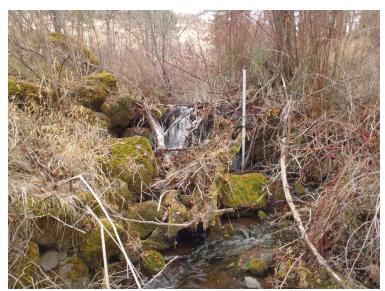
Blockage: None | <10% | >10% Falls were blocked by debris when surveyed. Cleaned out several logs while

Falls pugged by debris with no jump pool available

I was there

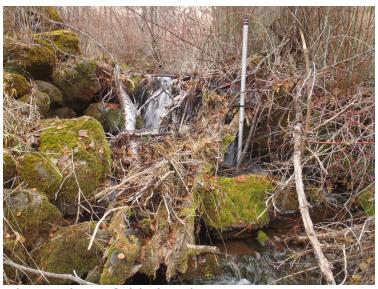
Closer view of this barrier
