Fish Passage Evaluation Field Log

Stream: Vester Cr at huge boulder

Road # 338 Passage ID: _____

Date: July, 19 2016 Crew: Neal

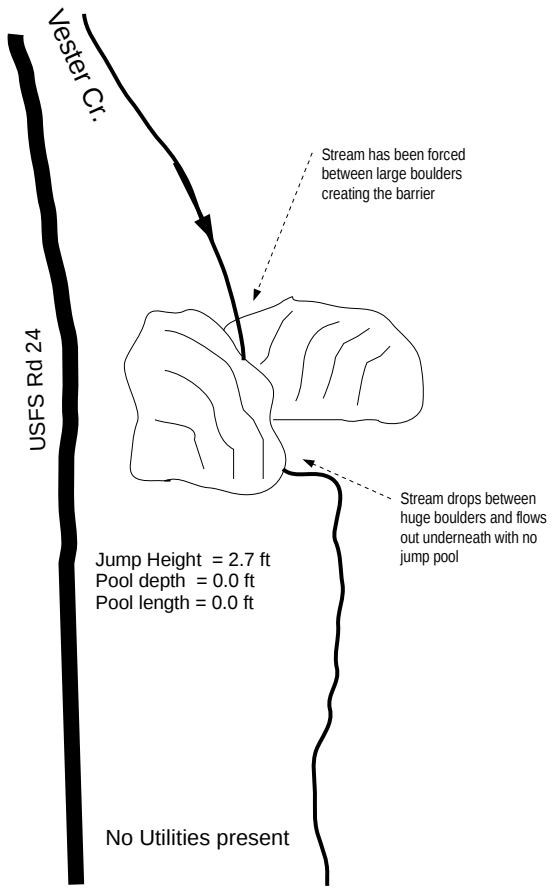
Sketch

Rating: **RED** | GREY | GREEN

Fish bearing: No | below only | **above** | potentially **Impassable** | adults only | juveniles | meets criteria

Jump height to Pool: 2.70 ft,

Debris blocking jump pool: **yes** Falls splatter onto a pile of rocks.
