Fish Passage Evaluation Data Sheet

Stream: Lemon Cr culvert #1

Road #233

Date: 7/06/17

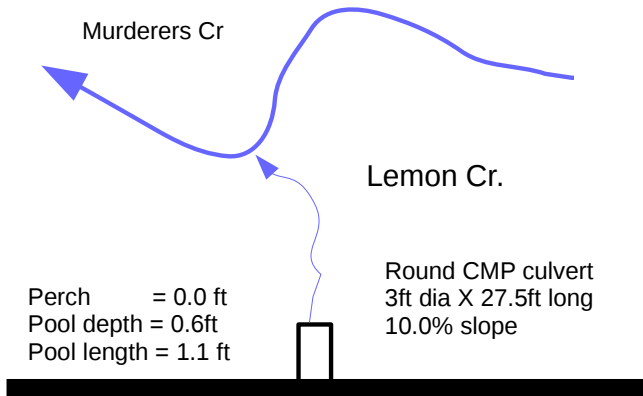
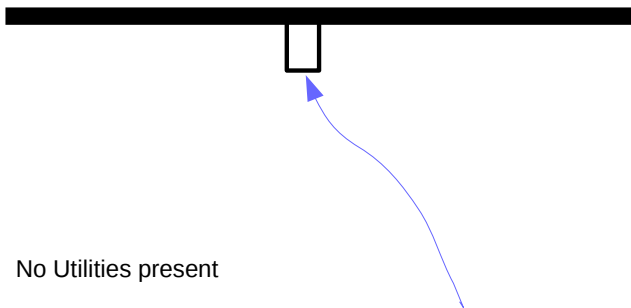
Sketch

USFS Rd 233
Road surface width = 13.0 ft
Skewed 5° from stream

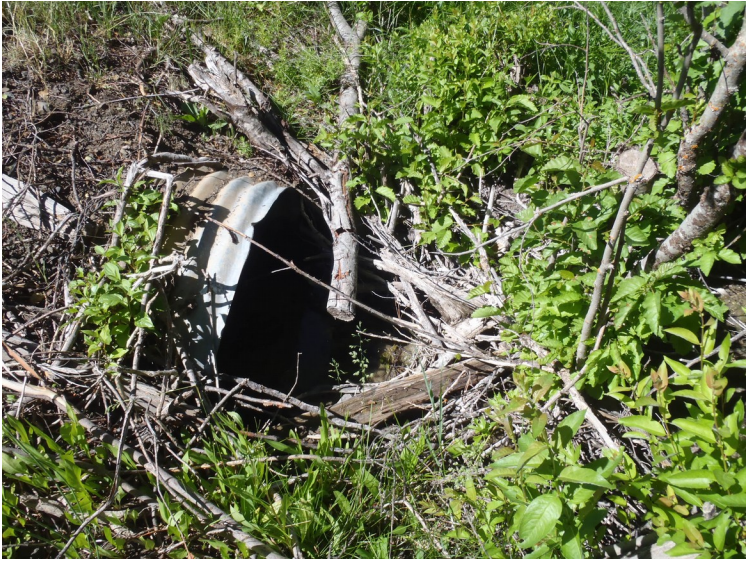
Debris blocking jump pool: **Yes** / No **Thick debris**

blocking jump pool

Condition: Bent inlet | **Debris plugging Outlet** | Bottom worn through| **Water under culvert** |

Lemon Cr culvert # 1 outlet plugged with debris

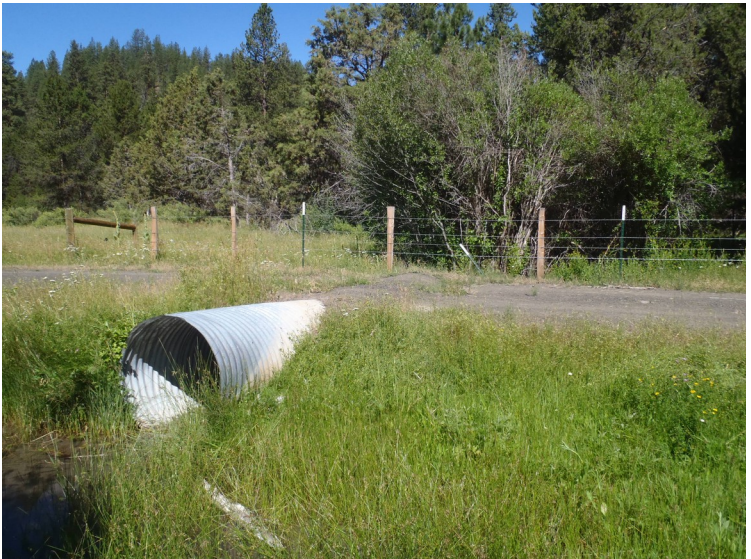
Top of culvert creates 8" bump in the road

Road Surface Height Above Inlet: 1.95 ft **Top of culvert inlet is 1 foot above the surface of the road**

Culvert Inlet and road bed showing bump
