Fish Passage Evaluation Data Sheet

Stream: Tennessee Cr #3

Road #899 Passage ID: _____

Date: 6/15/17 Crew: Neal

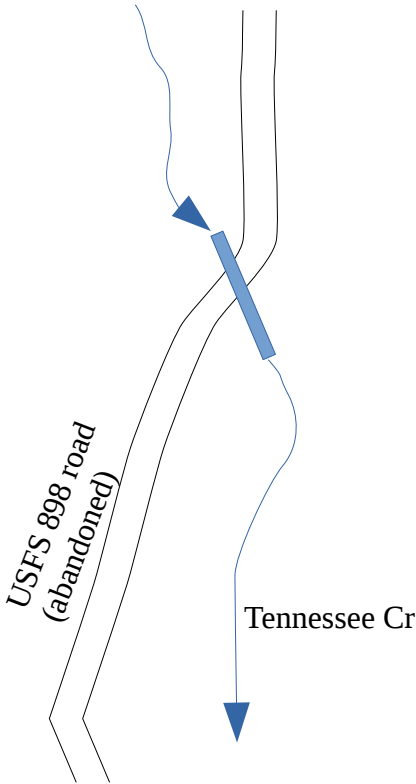
Sketch

Potential for debris blockage: **Yes** | No (**Inlet is 50% blocked by debris**)

Other: Culvert is too steep at 7.7%

Blockage: None | <10% | >10% 50% blocked with sticks and debris
