## Fish Passage Evaluation Field Log

Stream: Sfk Deer Cr check dams

Date: July 19, 2016 Crew: Neal

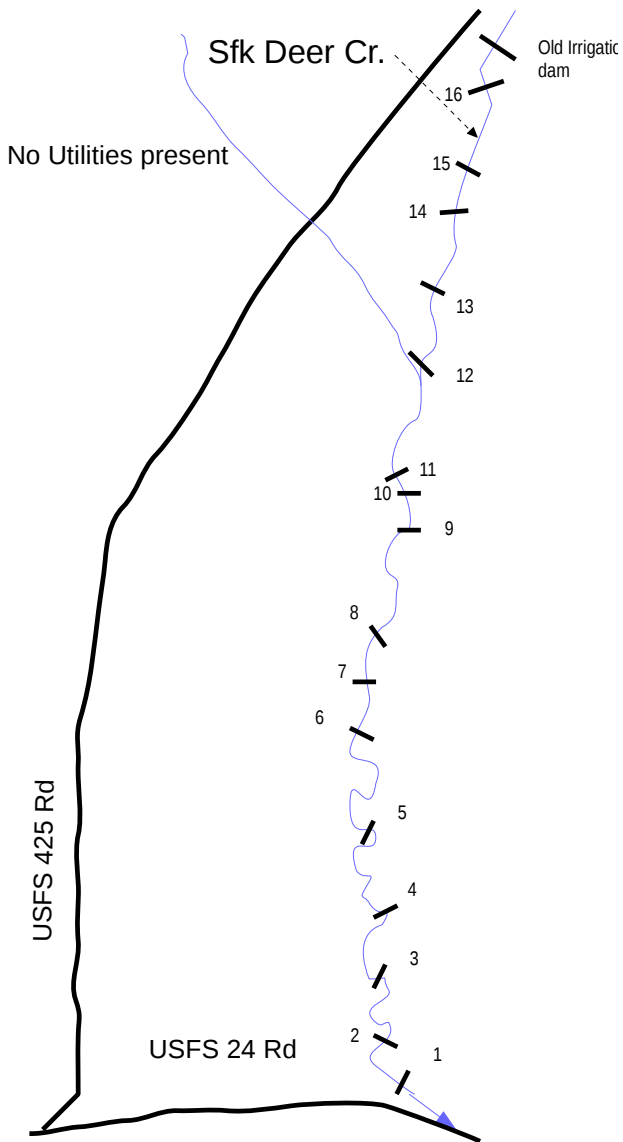
## Sketch

Notes: These check dams were installed in the 1970's to arrest channel incision and restore a severely degraded meadow. It was assumed the ponds behind them would fill with sediment within a few years and fish passage would be restored. Unfortunately the dams are porous to water, stopped all sediment flow and remain barriers to fish movement during all but the highest flows. Corrections need to be made in the form of sealing the face and the spillway of each impassable dam. Or the alternative of digging a new stream channel around them and using the excavated material to cover the dams. They are located in, and block access to, some of the best salmonid rearing habitat in the headwaters of Deer Creek.
