Fish Passage Evaluation Field Log

Stream: Nfk of Deer Cr rock check dams

Date: July 22, 2016 Crew: Neal

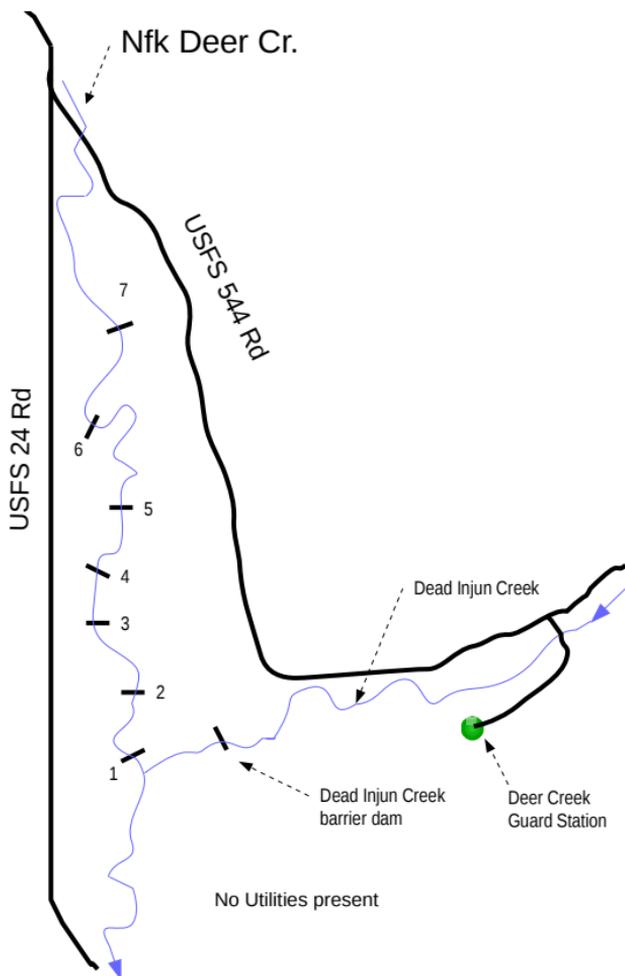
Sketch

Notes: These check dams were installed in the 1970's to arrest channel incision and restore a severely degraded meadow. It was assumed the ponds behind them would fill with sediment within a few years and fish passage would be restored. Unfortunately the

dams are porous to water, stopped all sediment flow and remain barriers to fish movement during all but the highest flows. Corrections need to be made in the form of sealing the face and the spillway of each impassable dam. Or the alternative of digging a new stream channel around them and using the excavated material to cover the dams. They are located in, and block access to, some of the best summer rearing habitat in Deer Creek and Dead Injun Creek.
